# Manhole Inspection Summary

Manhole # S61I\_\_011MH

Insp Date: **7/8/08 9:01 AM**

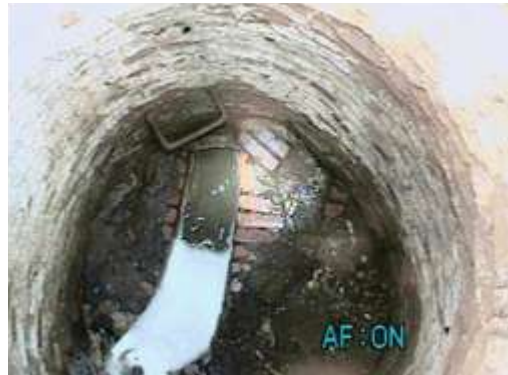
Top View

**Steps** Count: **3** Missing: **2** ☒ **Corroded**

and steps

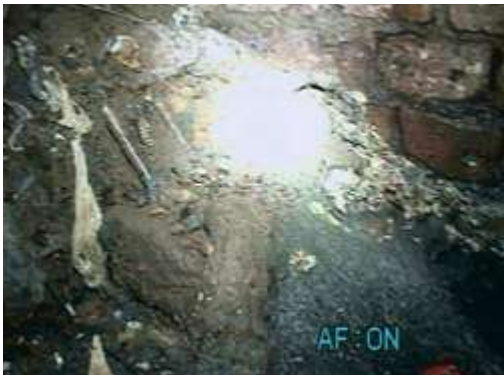
Defect 4

Condition: ☐ Sound ☐ Cracked ☐ Root Intrusion ☐ Deteriorated ☐ Leaks ☒ **Debris**

Bench and Channel Debris

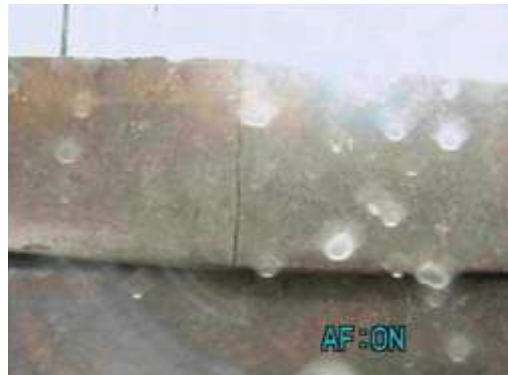
Defect 3

Type: **Sanitary** Condition: **Cracked** Cover Material: **Cast Iron**

cracked cover

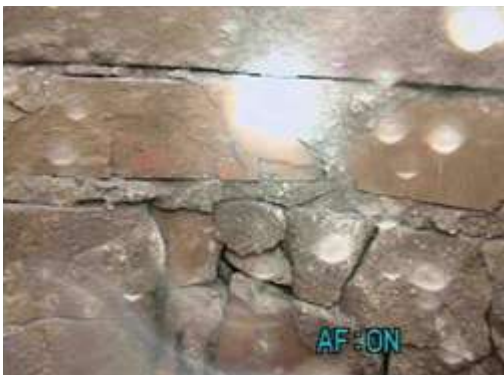
Defect 2

Condition: ☐ Sound ☒ **Cracked** ☐ Root Intrusion ☒ **Loose Brick** ☐ Deteriorated

frame adj

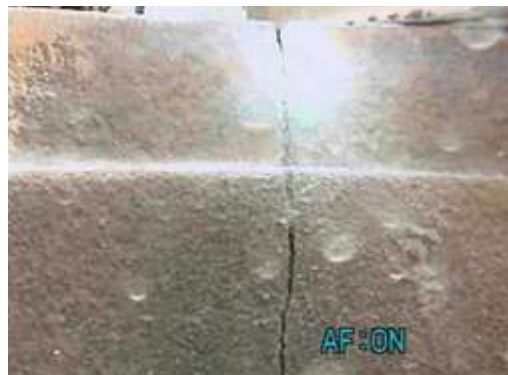
Defect 1

**Frame** Offset: **0** (in.) Condition: ☐ Sound ☒ **Cracked** ☐ Leaks

cracked frame
